Programed Repairs Engines 601, 602, 603 Mechanical III

03 Pistons

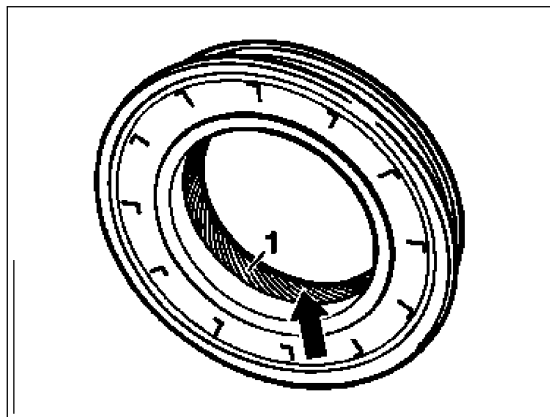
If oil leakages occur at the front of the crankshaft, it is only necessary in the most frequent cases to replace the crankshaft radial sealing ring. Replacing hub at the same time is only necessary in those cases where two wear tracks (grooves) are visible on the hub. For hubs which have only one wear track (groove) a radial seal with a sealing lip offset 2 mm to the rear is available (repair version). If the sealing surface of the hub is only ground bright, only the standard version of radial seal may be fitted.

Press the radial seal dry (without grease) into the timing case cover and coat the sealing lip (Fig., item 1) with engine oil - do not use grease.
